**Kings Park West
Community Association**

2010 Reserve Study

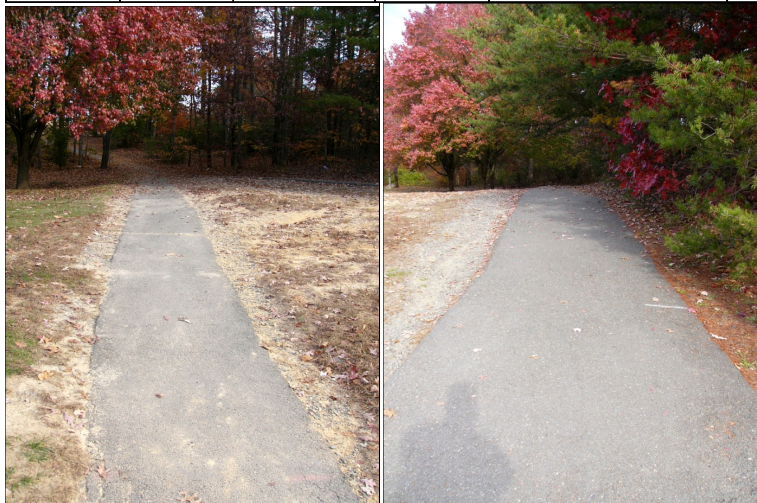
Property Description			Item	Access Between		Structure
Section 17	Outlot Z,	0684 09 Z	A.1	Commonwealth Blvd	Roberts Rd	Asphalt Concrete Walks
Section 17	Outlot Z,	0684 09 Z	A.2	Commonwealth Blvd	Roberts Rd	Asphalt Concrete Walks

Item	Access Between		Structure	Normal Useful Service Life	Remaining Useful Service Life	Condition
A.1	Commonwealth Blvd	Roberts Rd	Asphalt Concrete Walks	10	6	Good -Minor Cracking
A	4914 Heversham Ct	4911 Heversham Ct	Concrete Walk	25	10	Very Good
B	4790 Catterick Ct	4792 Catterick Ct	Concrete Walk	25	5	Fair/Good -Cracking & Settlement
A	10152 Bessmer Ln	10150 Bessmer Ln	Concrete Walk	25	0	68 Ft. of walk very poor
A	10152 Bessmer Ln	10150 Bessmer Ln	Stairs	25	10	Stairs and 4 Ft landing very good
A	10152 Bessmer Ln	10150 Bessmer Ln	Railing	25	10	Railing very good
B.1	10158 Tapestry Ct	10160 Tapestry Ct	Concrete/Stairs	25	10	Concrete -Very Good
B.1	10158 Tapestry Ct	10160 Tapestry Ct	Railing	25	10	Railing very good
				Maintenance Schedule	Remaining Useful Service Life	Condition
A	Commonwealth	Twinbrook	Entrance sign - Brick/Masonry	25	20	Very Good, Isolated area need immediate repair
C.1	Easement		Entry Wall/Sign	25	5	Good, plan on repairs to half of wall in 5 years

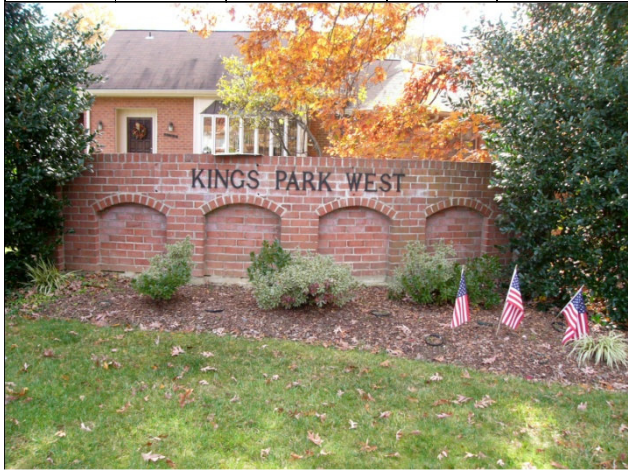
Property Description			Item	Access Between	Structure
Section 16	Lot 1184	0684 09 1184	C.2	Easement	Entry Wall/Sign -Mortar

C.2	Easement		Entry Wall/Sign	25	5	Good, plan on repairs to half of wall in 5 years
