**Kings Park West
Community Association**

2015 Reserve Study

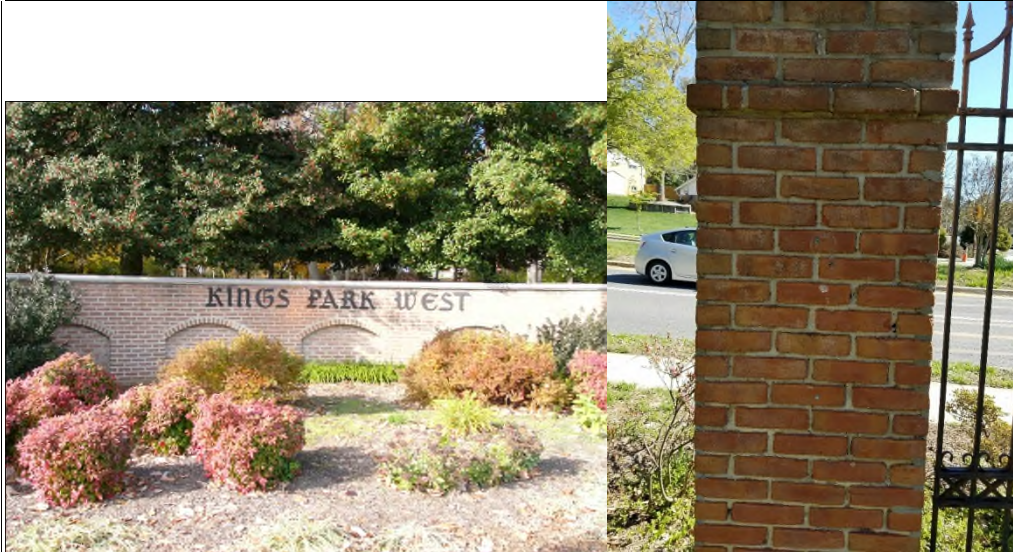
Property Description			Item	Access Between		Structure
Section 1	Outlot B,	0693 05 B1	A	Commonwealth Blvd	Twinbrook	Entrance sign - Brick/Masonry

Minor repointing is required on the back side of the C.1 entrance wall and also on the backside of the main Commonwealth/Twinbrook wall. The repointing is necessary to protect against freeze/thaw damage that could increase the localized area of repairs. An annual inspection of the brick walls should be performed with localized repointing as necessary to protect the structures and extend their useful life.

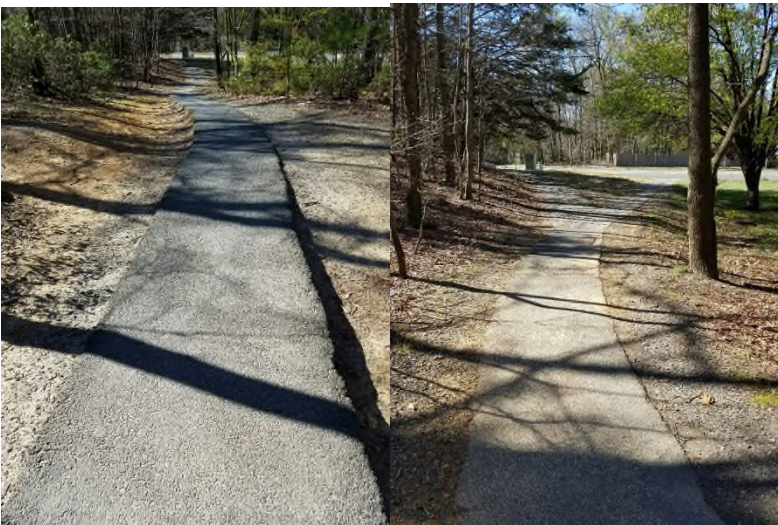
Property Description			Item	Access Between		Structure
Section 17	Outlot Z,	0684 09 Z	A.1	Commonwealth Blvd	Roberts Rd	Asphalt Concrete Walks
Section 17	Outlot Z,	0684 09 Z	A.2	Commonwealth Blvd	Roberts Rd	Asphalt Concrete Walks

Clean cracks of debris and plant growth and fill with a rubberized asphaltic compound every three to six years to prevent water infiltration. Applying asphalt seal coating can also further extend its useful service life.

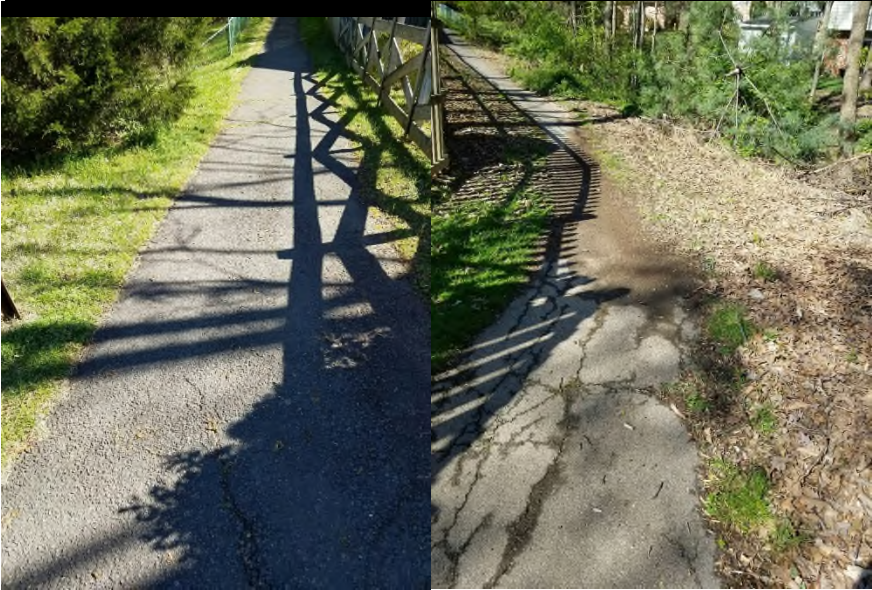
Property Description			Item	Access Between		Structure
Section 21	Parcel A,	0682 05 A	B	4833 Gainsborough Dr	4835 Gainsborough Dr	Asphalt Concrete Walks Maintained by DPWES

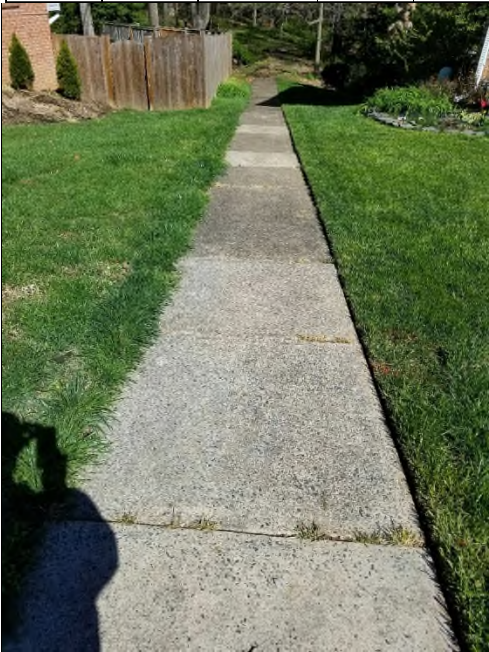
Property Description			Item	Access Between		Structure
Section 21	Parcel B,	0682 05 B	A	4914 Heversham Ct	4911 Heversham Ct	Concrete Walk

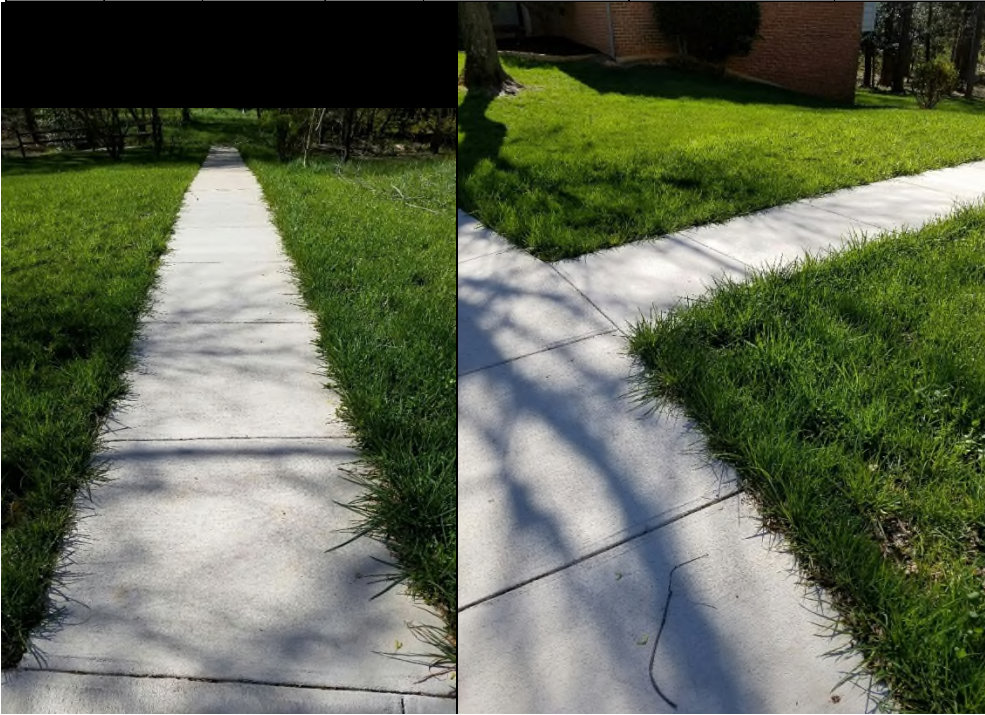
In the previous Report, the walkway at Catterick Ct. (Item 9.B) was scheduled for demolition and replacement with sod in 2016. Upon inspection, the walkway has been replaced with new concrete. It is unclear if the County or adjacent homeowners replaced the walkway, although a section of the County sidewalk adjacent to the HOA walkway was also replaced. Accordingly, costs for demolition and sodding for this asset have been removed from this year's report.

Property Description			Item	Access Between		Structure
Section 21	Parcel B,	0682 05 B	B	4790 Catterick Ct	4792 Catterick Ct	Concrete Walk

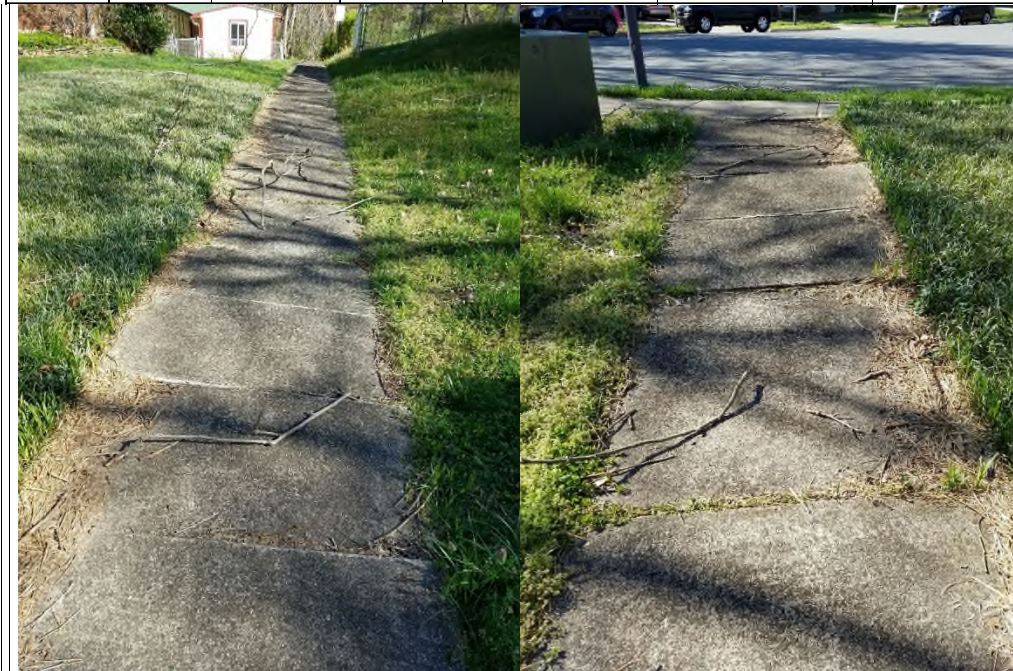
Property Description			Item	Access Between		Structure
Section 22	Parcel C,	0682 05 C	A	10152 Bessmer Ln	10150 Bessmer Ln	Concrete Walk

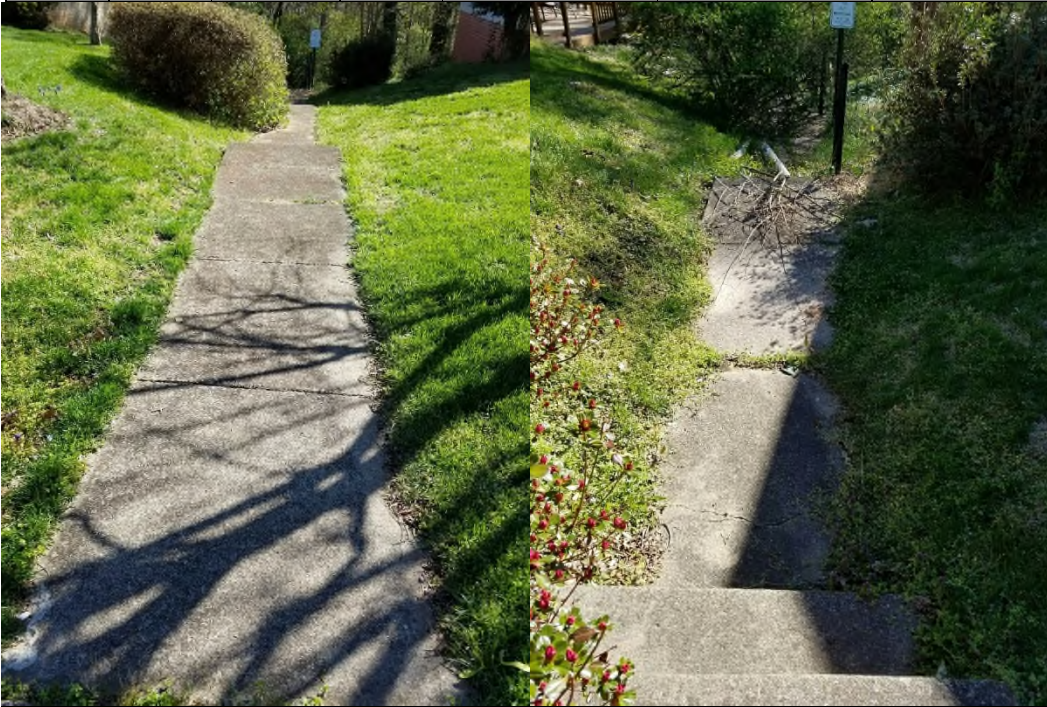
Property Description			Item	Access Between		Structure
Section 22	Parcel C,	0682 05 C	B.1	10158 Tapestry Ct	10160 Tapestry Ct	Concrete Walk
Section 22	Parcel C,	0682 05 C	B.2	10158 Tapestry Ct	10160 Tapestry Ct	Concrete Walk

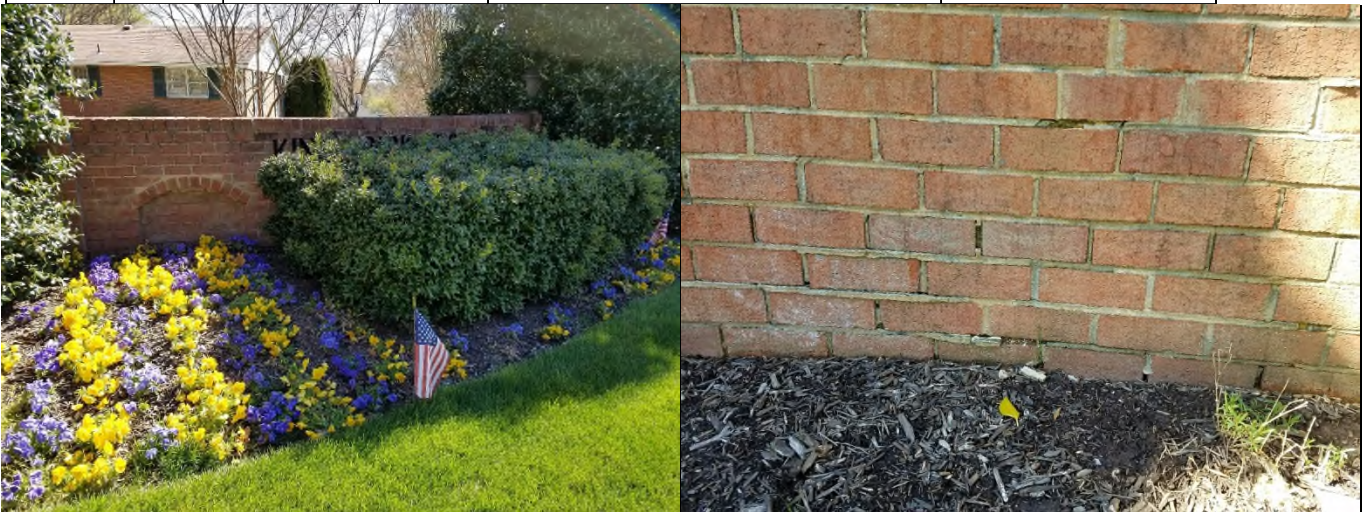
Item	Access Between		Structure	Normal Useful Service Life	Remaining Useful Service Life	Condition
A.1	Commonwealth Blvd	Roberts Rd	Asphalt Concrete Walks	10	6	Good -Minor Cracking
A	4914 Heversham Ct	4911 Heversham Ct	Concrete Walk	25	10	Very Good
B	4790 Catterick Ct	4792 Catterick Ct	Concrete Walk	25	25	Excellent - Recently Replaced
A	10152 Bessmer Ln	10150 Bessmer Ln	Concrete Walk	25	0	68 Ft. of walk very poor
A	10152 Bessmer Ln	10150 Bessmer Ln	Stairs	25	10	Stairs and 4 Ft landing very good
A	10152 Bessmer Ln	10150 Bessmer Ln	Railing	25	10	Railing very good
B.1	10158 Tapestry Ct	10160 Tapestry Ct	Concrete/Stairs	25	10	Concrete -Very Good
B.1	10158 Tapestry Ct	10160 Tapestry Ct	Railing	25	10	Railing very good
A	Commonwealth	Twinbrook	Entrance Sign- Brick Masonry	25	15	Very Good, Isolated area in need of repair
C.1	Easement		Entry Wall/Sign	25	5	Good, minor repairs needed 2016, plan on repairs to half of wall in 5 years

Property Description			Item	Access Between	Structure
Section 16	Lot 1182	0684 09 1182	C.1	Easement	Entry Wall/Sign -Mortar

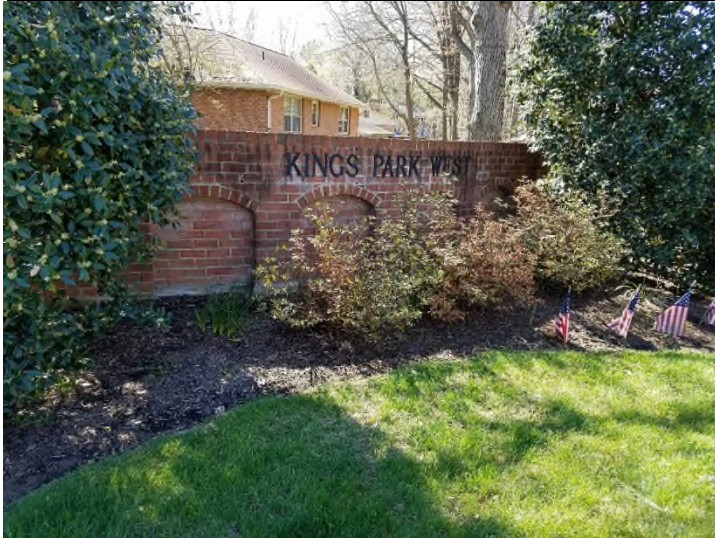
C.2	Easement		Entry Wall/Sign	25	5	Good, plan on repairs to half of wall in 5 years

Property Description			Item	Access Between	Structure
Section 16	Lot 1184	0684 09 1184	C.2	Easement	Entry Wall/Sign -Mortar
